Experimental Study ND 91-04

**Evaluation of Silane and Various Hot
Bituminous Overlay Thicknesses
Final Report**

Project IR-094-6(064)193

July 1997

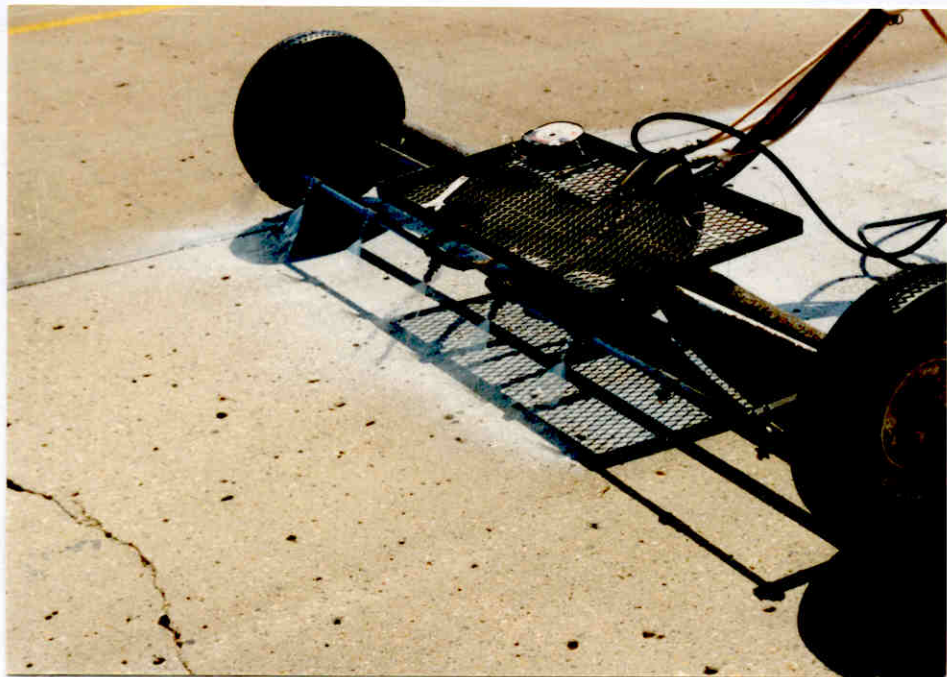
Photo 1. Overview of the silane application on I-94.

The same contractor that applied the silane south of Fargo also applied silane on this project. The contractor had improved on their application methods used on the project south of Fargo. The pressure had been increased and a carpet was used around the parameter of the spray nozzles to improve the application (photo 1).

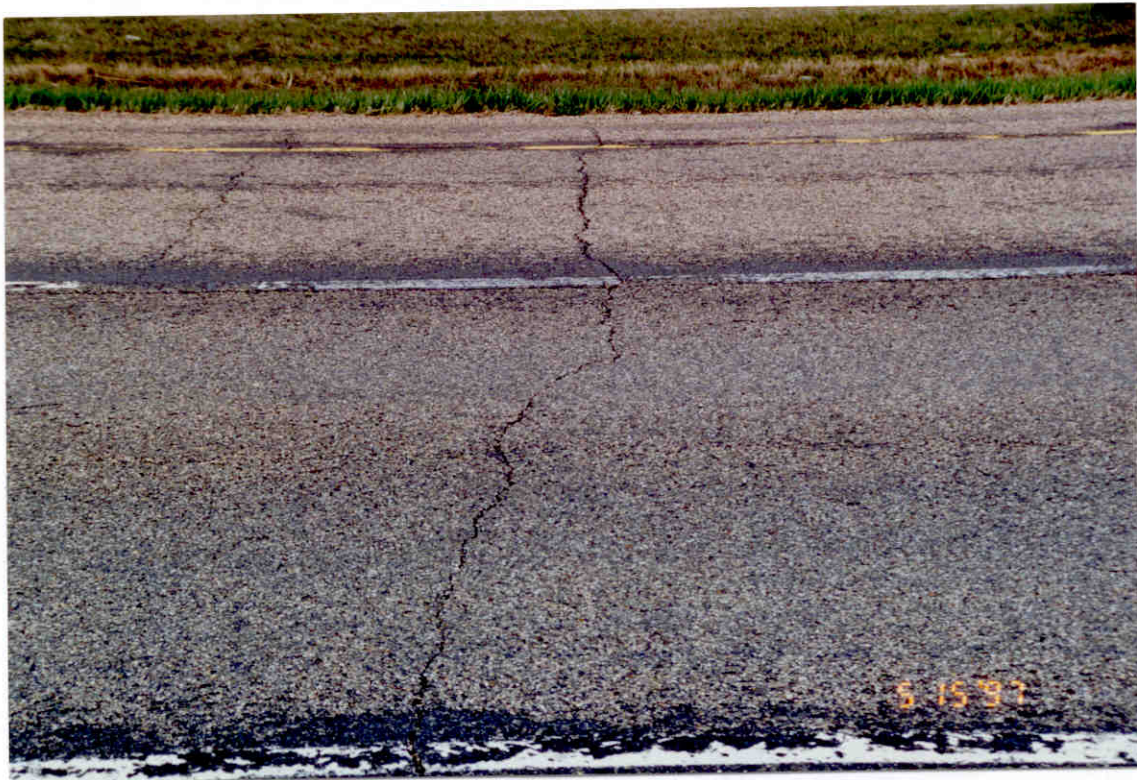
Westbound 2" HBP Overlay (Section 5)

Photo 2 depicts a typical transverse crack in this test section. Total full length transverse cracks registered in a 1500' stretch of roadway is approximately 227. Most of the cracks appear to be tight. No noticeable rutting was present. The general surface appearance of the 2" HBP overlay as well as the with the 2 1/2", 3", & 4" HBP overlays is due to a chip seal placed in 1995 that has partially failed.

Photo 2. View of a typical crack in the 2" overlay test section.

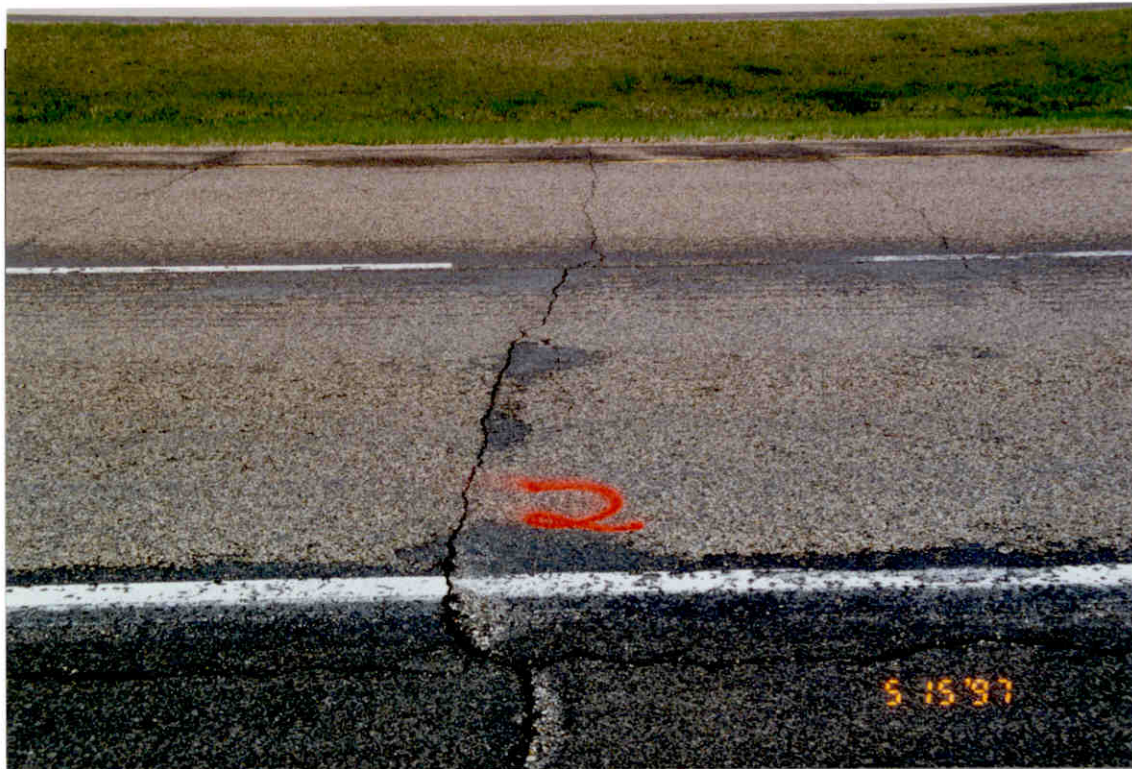
Westbound 2 1/2" HBP Overlay (Section 4)

Photo 3 depicts a typical transverse crack in this test section. Total full length transverse cracks registered in a 1500' stretch of roadway is approximately 185. In the fourth annual report the number of cracks reported were 207, however, upon further examination of the notes a figure of 169 was more accurate. A total of approximately 16 more transverse cracks have progressed to three-quarters or more of full length since the last evaluation. Most of the cracks appear to be tight. There does not appear to be any noticeable rutting.

Photo 3. A typical transverse crack located in the 2 1/2" overlay test section.

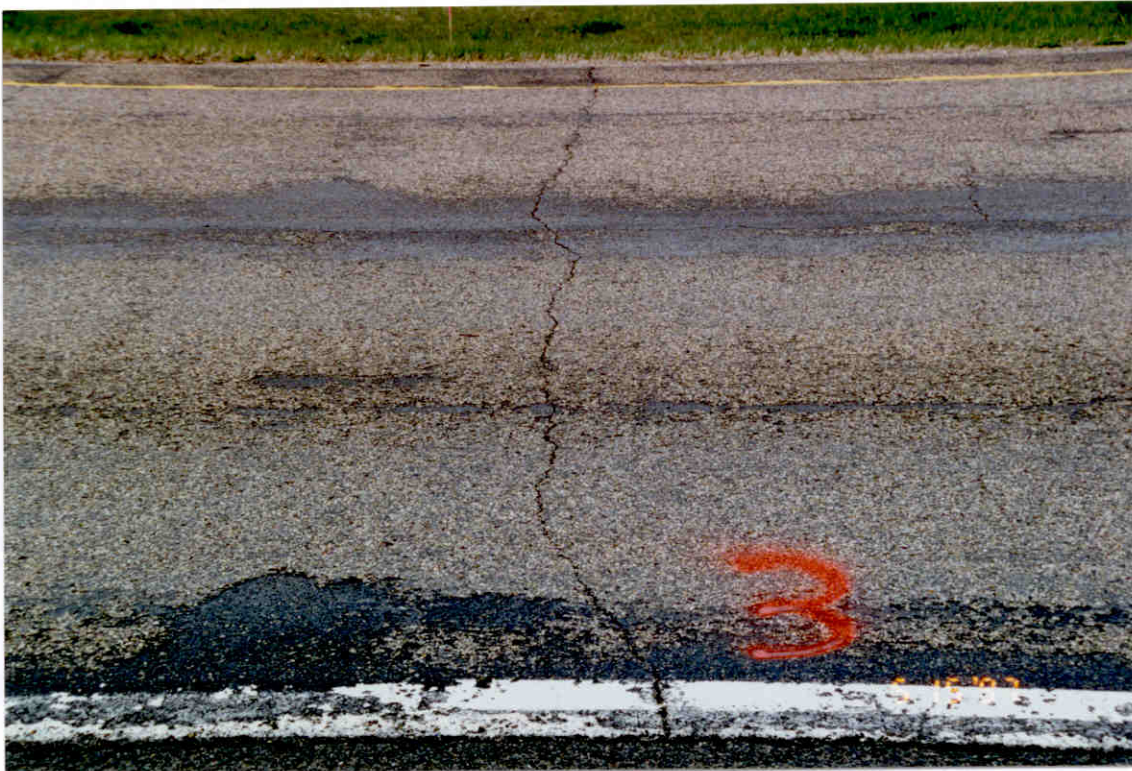
Westbound 3" HBP Overlay (Section 3)

Photo 4 depicts a typical crack in this test section. Total full length transverse cracks registered in a 1500' stretch of roadway is approximately 169. Most of the cracks appear to be tight. There does not appear to be any noticeable rutting.

Photo 4. View of a typical transverse crack in the 3" overlay test section.

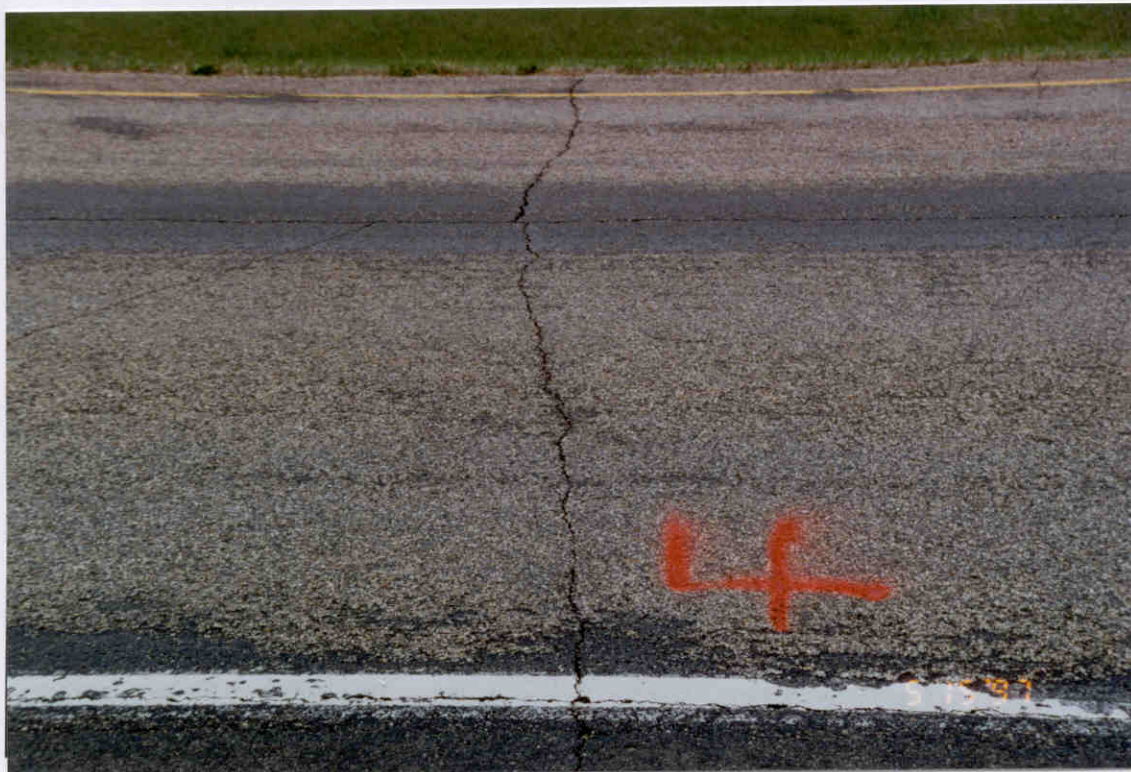
Westbound 4" HBP Overlay (Section 2a)

Photo 5 depicts a typical crack in this test section. Total full length transverse cracks registered in a 1500' stretch of roadway is approximately 90. Many of the crack widths look slightly wider than the other sections. There does not appear to be any noticeable rutting.

Photo 5. Typical transverse crack in the 4" overlay test section (WB).

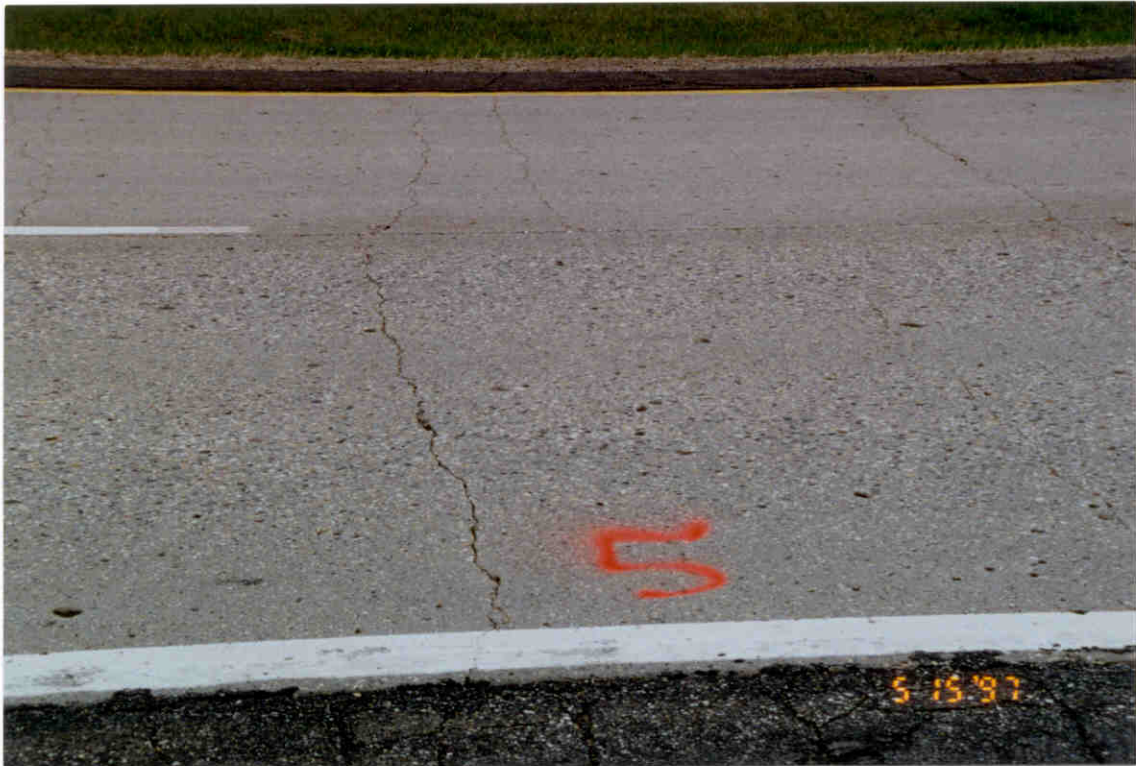
Photo 6 shows a view of a typical section of roadway located in the silane test section.

Photo 6. Overview of typical cracks located in the test section.

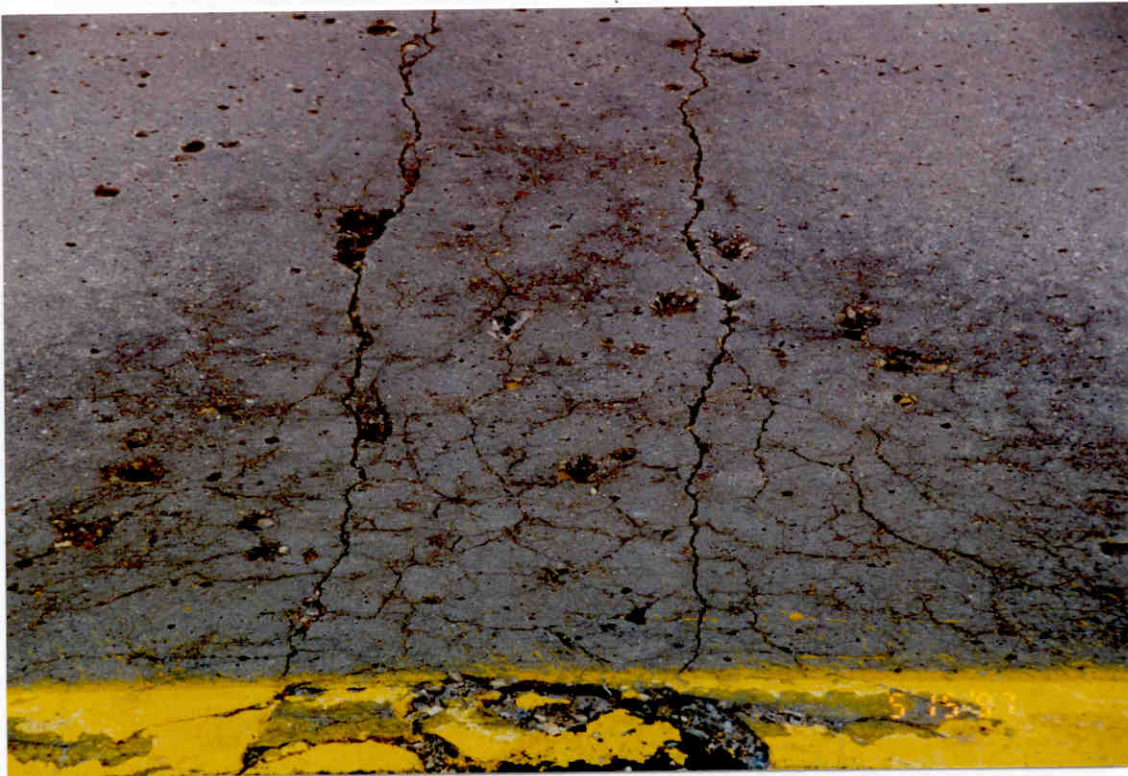
Photo 8 shows a close-up of one of these areas located in the control section. The staining effect seen in photo 8 encompasses several microcracks between the two major cracks.

At this point in the evaluation period, the silane section appears to be performing slightly better than the control section in slowing the progression of the "D" cracking.

Photo 8. Close-up view of a distressed area near the edge line in the control section.

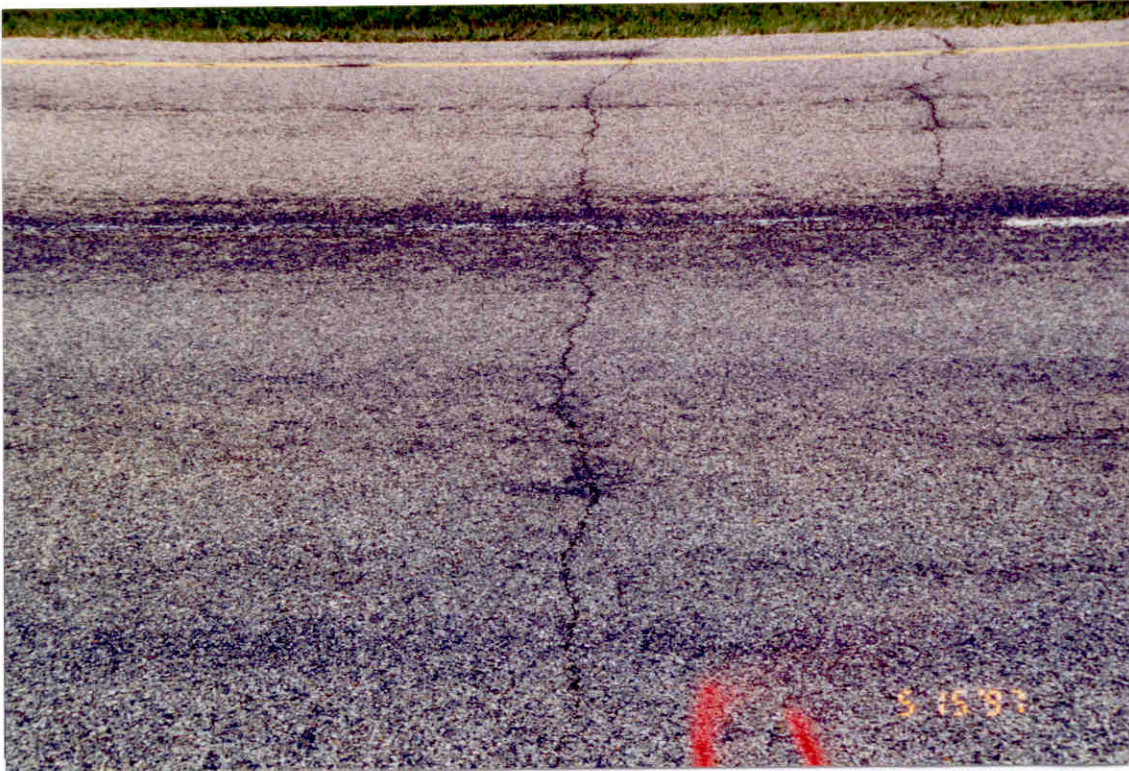
Eastbound 4" HBP Overlay (Section 2b)

Photo 9 depicts a typical crack in this test section. Total full length transverse cracks registered in a 1500' stretch of roadway is approximately 140. Most of the crack widths appear closer together than the westbound 4" section. There does not appear to be any noticeable rutting.

Photo 9. A view of a typical crack in the 4" overlay test section (EB).
